S315 River Crane, Feltham

Client :
Network Rail

Designer :
Mott MacDonald

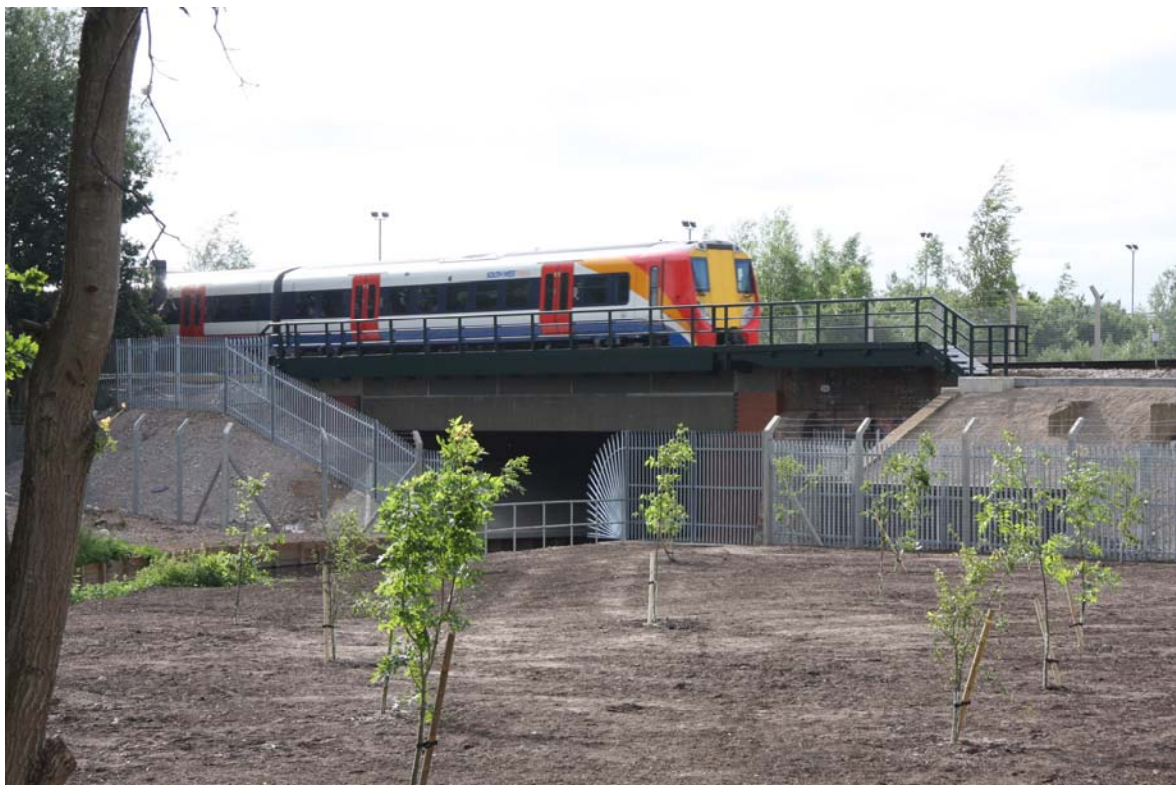
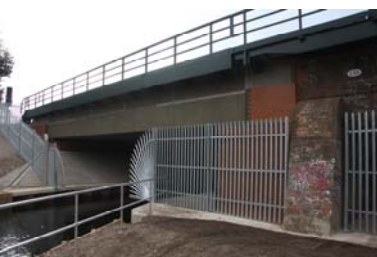
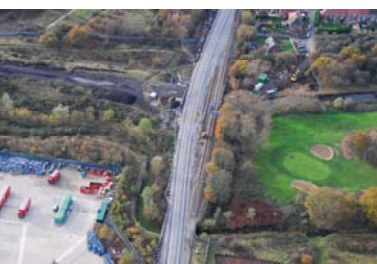
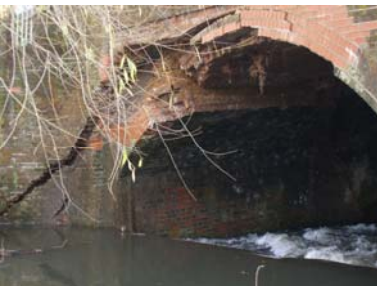
Very heavy rainfall caused the London end abutment of Bridge 3/48 to fail as a result of the swollen River Crane scouring away the supporting gravel layer beneath the abutment. As a result, train services on the main Reading to London Waterloo lines across this bridge were interrupted.

The permanent bridge reconstruction featured a new bridge deck on new piled abutments using pre-stressed, pre-cast concrete beams.

Once piling works were completed and scour protection sheet piles were installed, the existing structure was demolished and new bridge beams installed during railway possessions using a 500t mobile crane. The remaining bridge components (robust kerbs, ballast walls, waterproofing etc) and walkway were then erected and the structure backfilled.

BAM Nuttall worked closely with Network Rail to prepare and implement a plan to restore train services as soon as possible whilst permanent repairs were being carried out. It was decided to temporarily divert the railway onto an adjacent piece of land and install support to the failed abutment.

Over a three month period we successfully diverted the operational railway, designed and built a brand new structure complete with piled abutments, installed a sheet piled scour protection solution to prevent reoccurrence and returned the rail service onto its original alignment.
